Vendor's building survey report

## Twenty Old Bailey, London EC4M 7AN

Prepared for: Hines UK Ltd  
Prepared by: Simon Devlin BSc (Hons) MRICS  
Mark Hannan  
Issue date: 14 March 2023  
Report stage: Final  
Reference: 119279-101/SGD

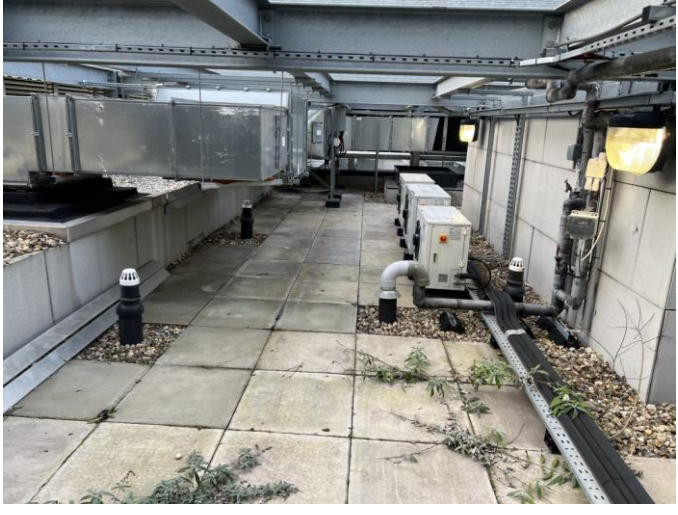
| 2. | Vegetation to main roof | |

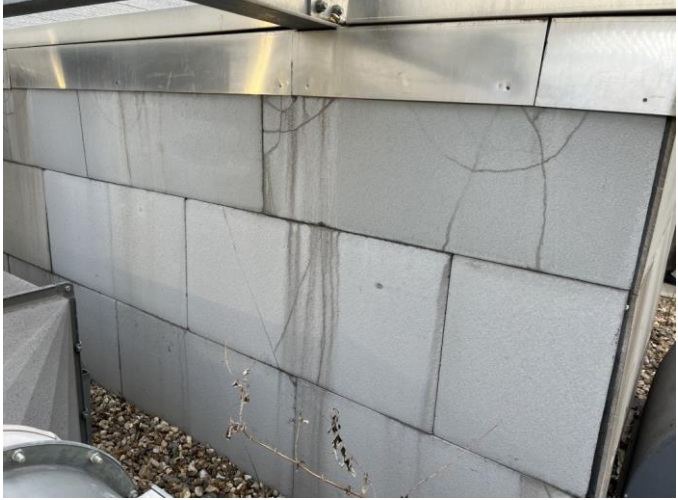
- There is cracking to the fibre cement boards lining the plant rooms at roof level; presumably from impact damage. This is aesthetic only.

| 3. | Cracking to fibre cement boards to plant enclosures, main roof | |

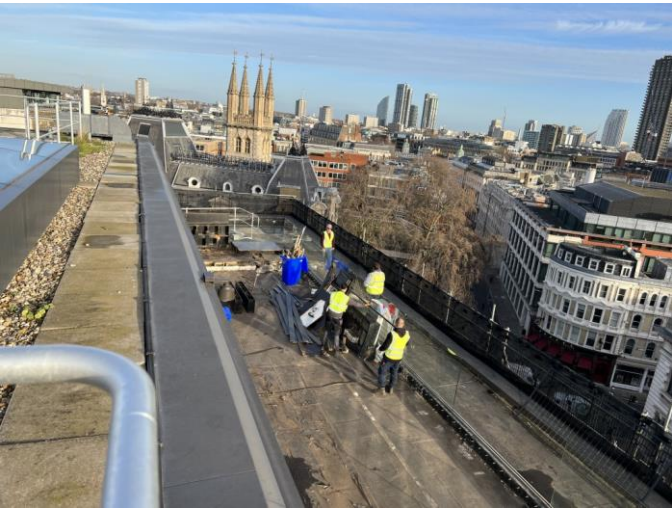
- At the time of inspection we were advised of one current leak in the area of the 6<sup>th</sup> floor, which was reportedly associated with the balcony over. We were not afforded access to the 6<sup>th</sup> and 7<sup>th</sup> floors and therefore we were unable to inspect for ourselves. Building management confirmed that this was being investigated and a repair would be actioned in due course.

| 4. | On-going works to 9 <sup>th</sup> floor balcony | |

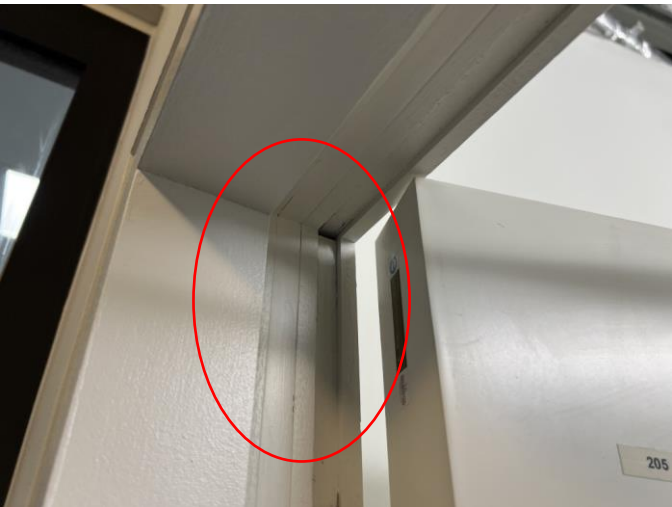
| 6. | Missing fire seal to fire door, 8 <sup>th</sup> floor | |

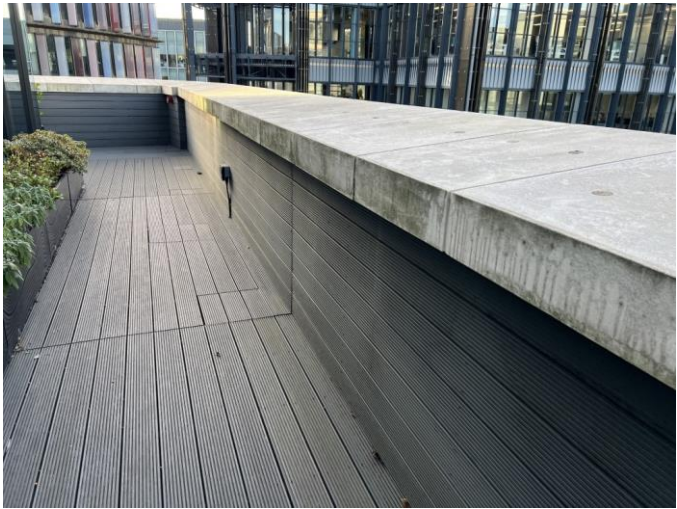
- Soiling is evident to the copings around the 8<sup>th</sup> floor balconies. Periodic cleaning is recommended as part of a robust planned maintenance regime.

| 7. | Soiling to copings, 8 <sup>th</sup> floor | |

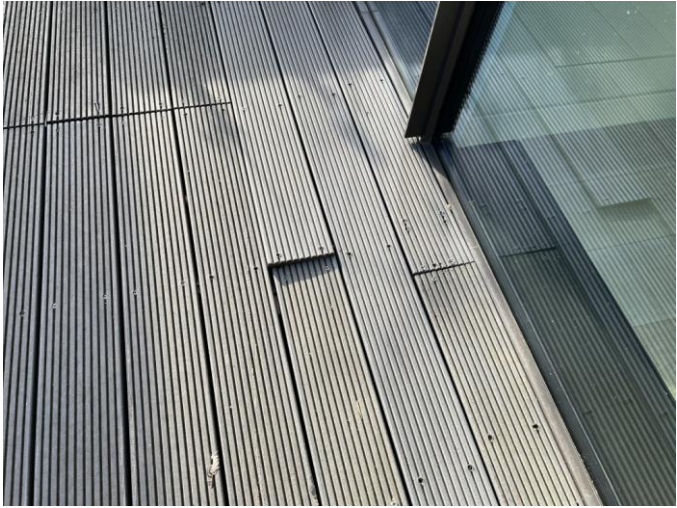
| 8. | Uneven decking board, 8 <sup>th</sup> floor balcony | |

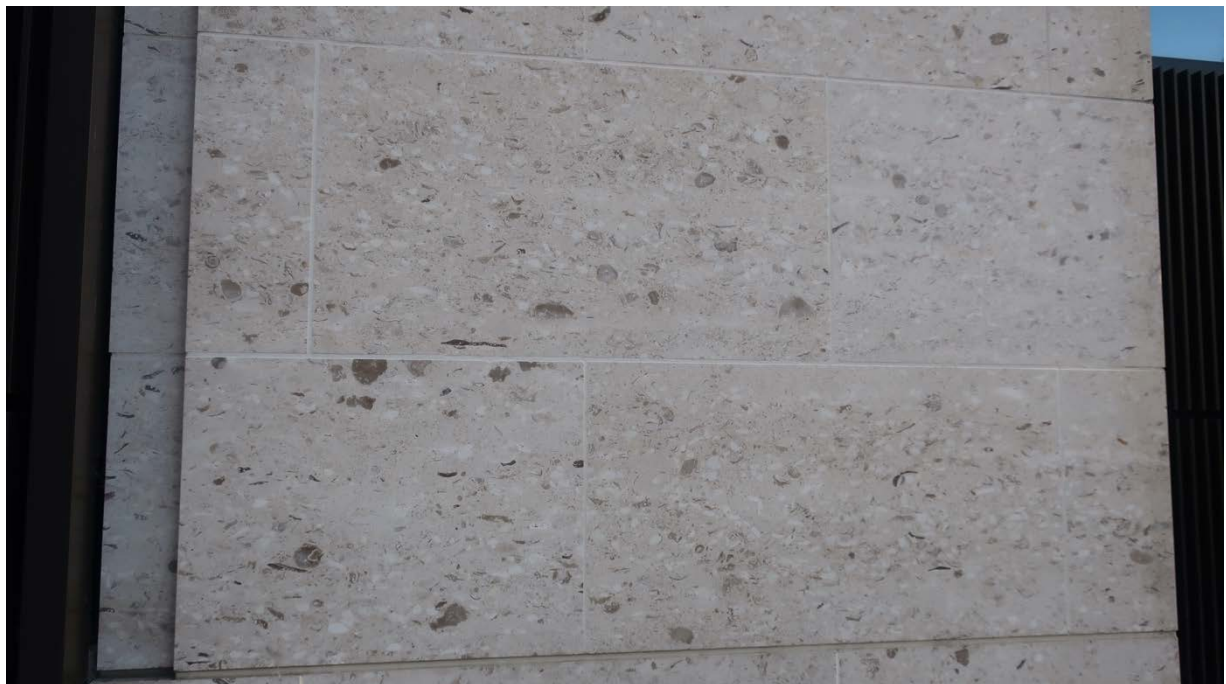
**Photograph 4 – Close view of the 2017 installed Moleanos stonework in a satisfactory condition.**

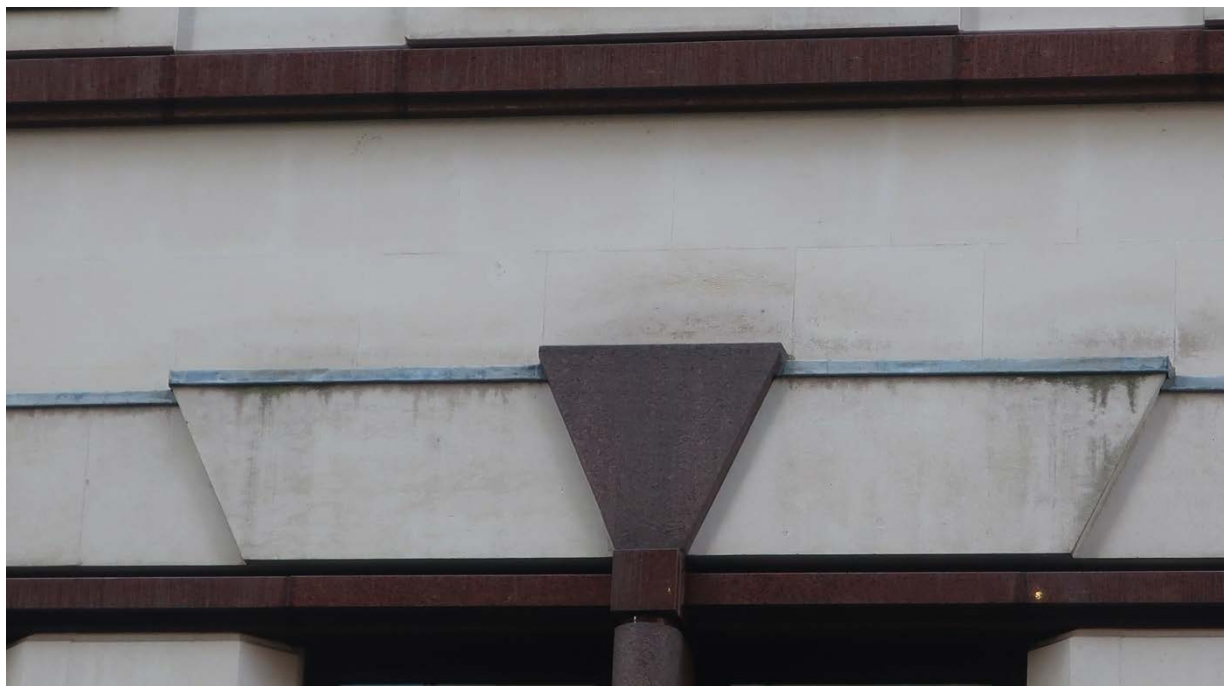
**Photograph 14 – Localised damp and algae staining to the original stonework.**

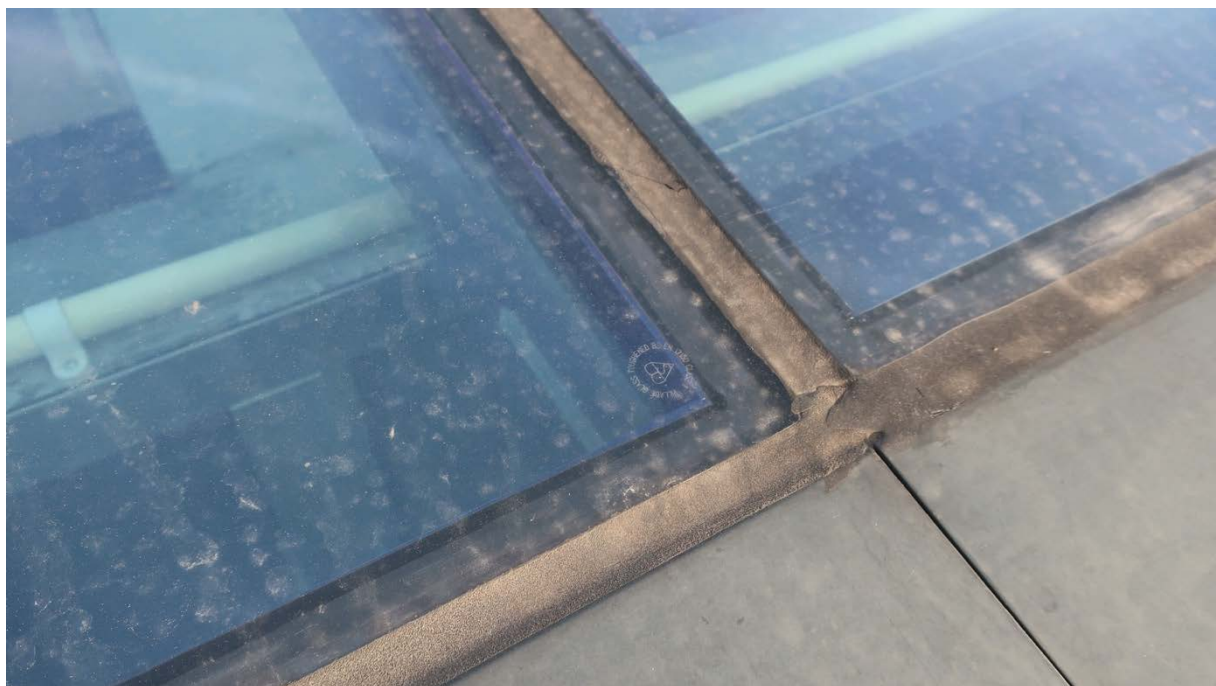
**Photograph 18 – Close of the atrium roof silicone seals in a satisfactory condition.**

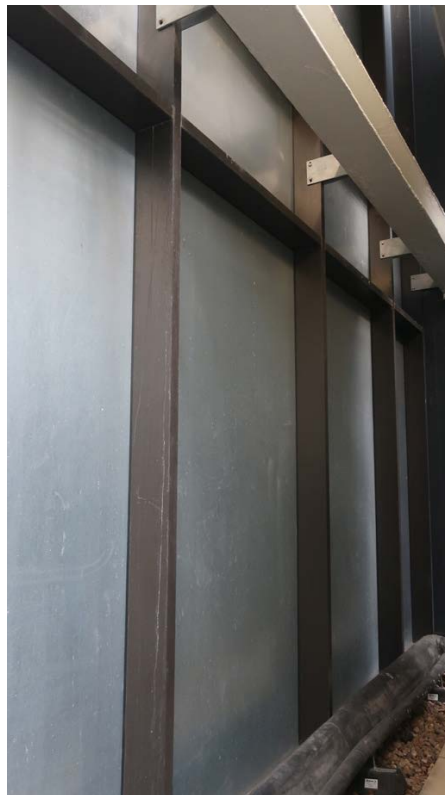
**Photograph 20 – The Rockspan composite panels to the plant enclosure are general inaccessible to view.**

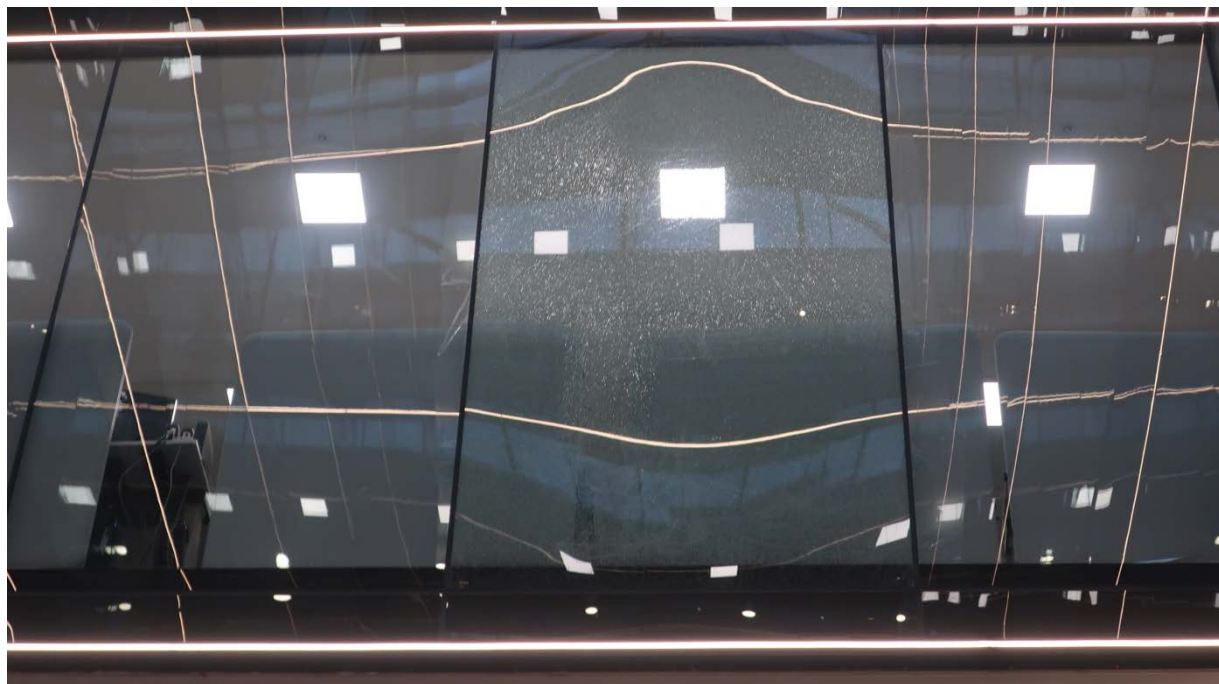
**Photograph 21 – Internal atrium wall showing shattered panel at Level 2.**

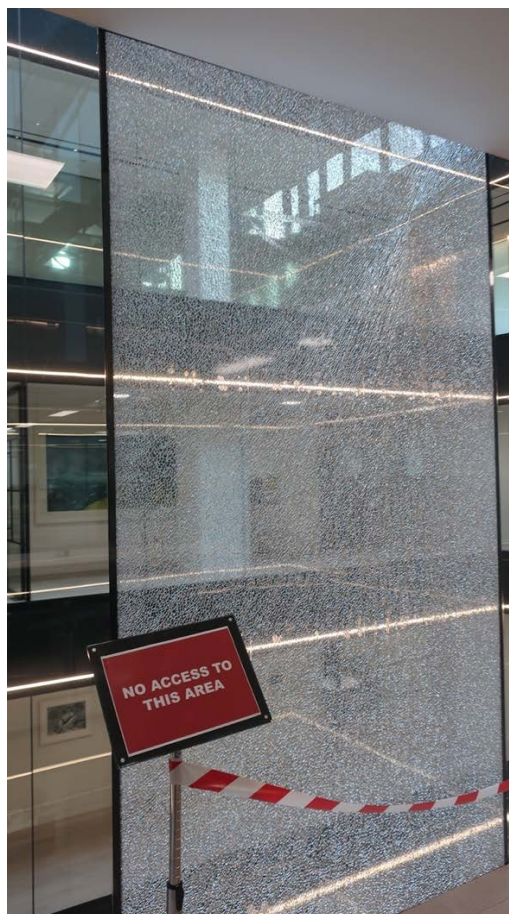
**Photograph 22 - Internal atrium wall showing shattered panel at Level 7.**
