Vendor's building survey report

## Twenty Old Bailey, London EC4M 7AN

Prepared for: Hines UK Ltd  
Prepared by: Simon Devlin BSc (Hons) MRICS  
Mark Hannan  
Issue date: 14 March 2023  
Report stage: Final  
Reference: 119279-101/SGD

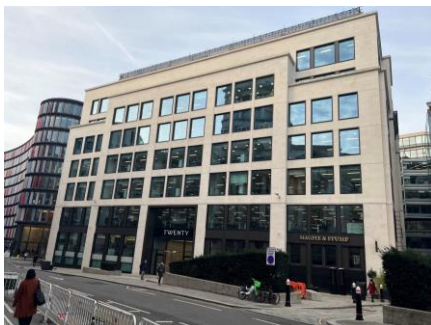
Photo of the front elevation, east facing

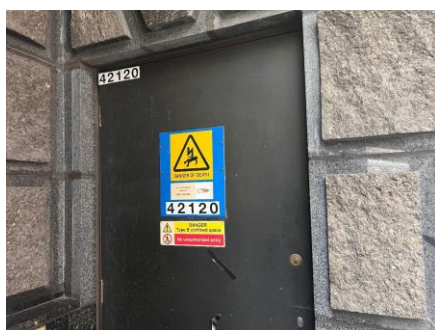
- 2.5.3. An electricity substation operated by EDF Energy is present at basement level.
- 2.5.4. Under the Environmental Protection (Disposal of Polychlorinated Biphenyls & Other Dangerous Substances) (England & Wales) Regulations 2000 (as amended, the use of PCBs is banned. Transformers containing less than 50 parts per million (ppm) PCBs can continue to be used until the end of their useful life; however, if they contain more than 50 ppm PCBs, they must be registered with the EA and the registration renewed annually. Transformers with between 50 ppm (0.005%) and 500 ppm (0.05%) by weight of PCBs, or a total volume of more than 0.05dm<sup>3</sup> of PCBs can be used until 31 December 2025, after which time they must be decontaminated or disposed of. Responsibility for compliance, maintenance and ground contamination associated with the sub-station should be the responsibility of the sub-station operator. This should be confirmed by your solicitor.

Photo of the substation.

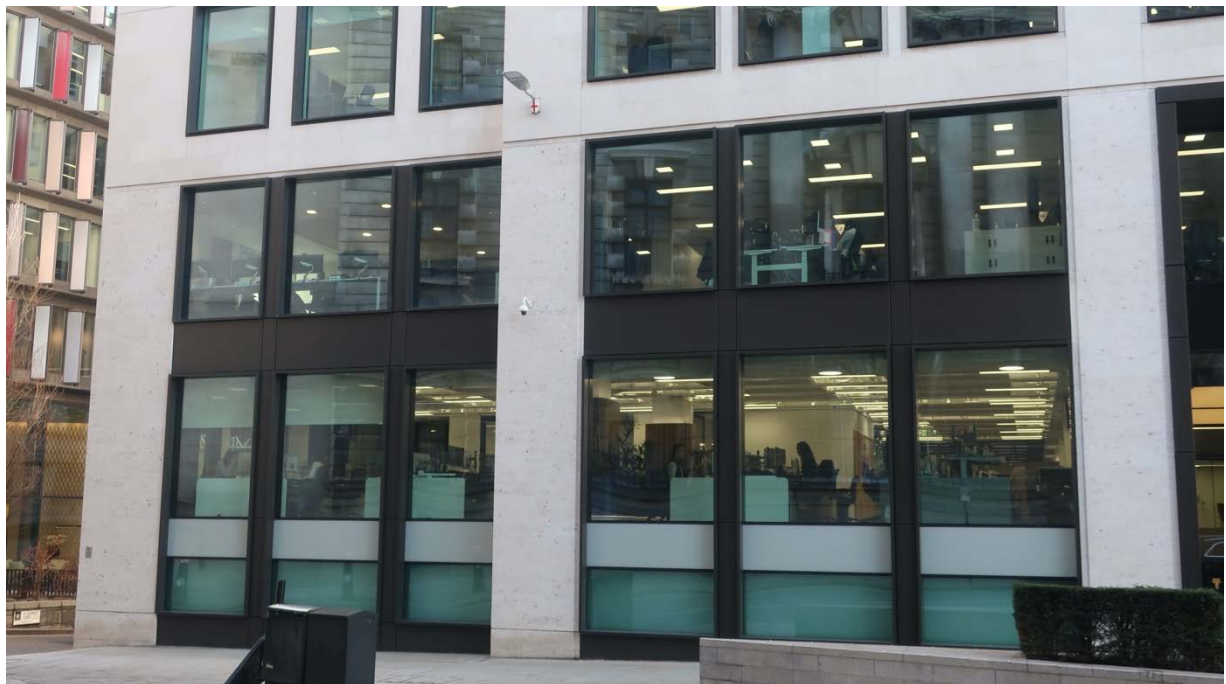
**Photograph 2 – Front elevation showing the 2017 installed infill curtain walling.**

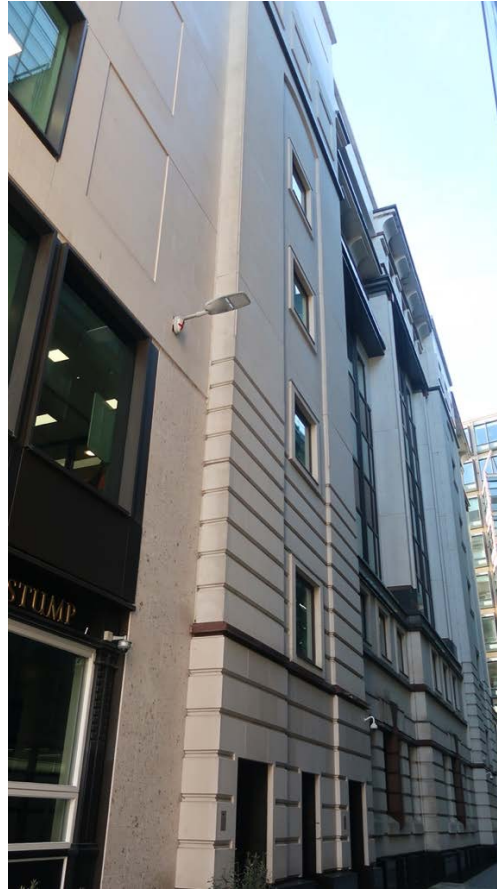
**Photograph 5 – North elevation.**  
(2017 stonework on the left and original stonework on the right)

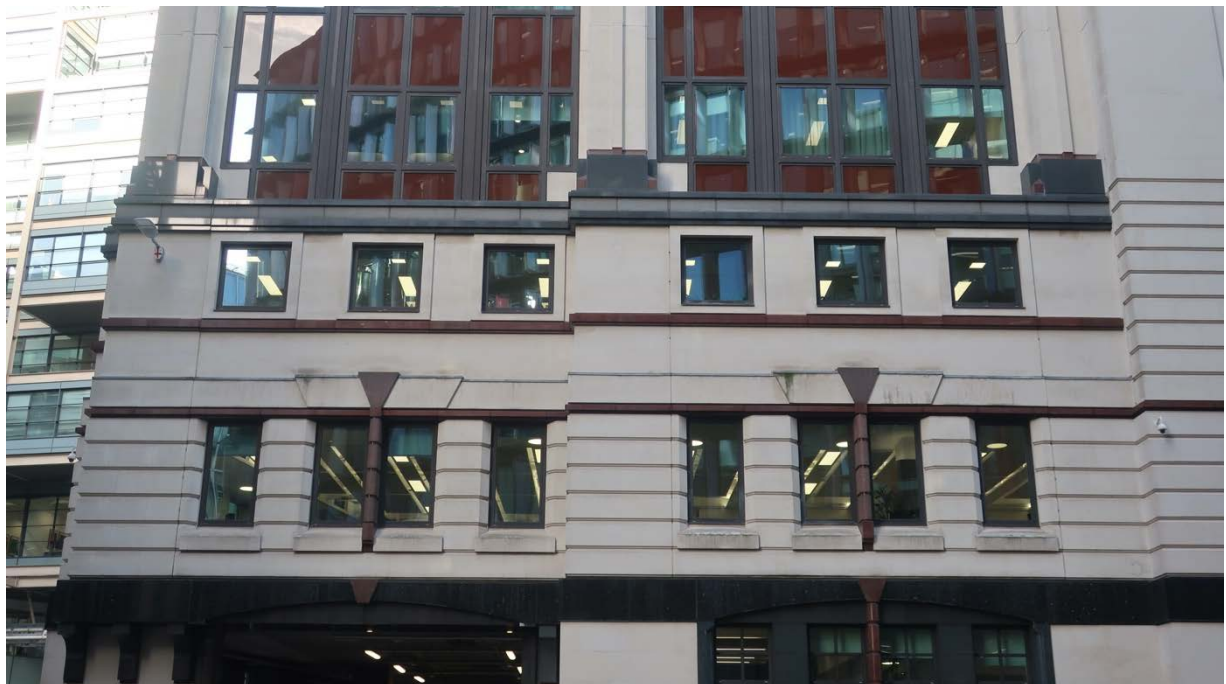
**Photograph 8 – Part view of the south elevation showing the original stonework and windows.**

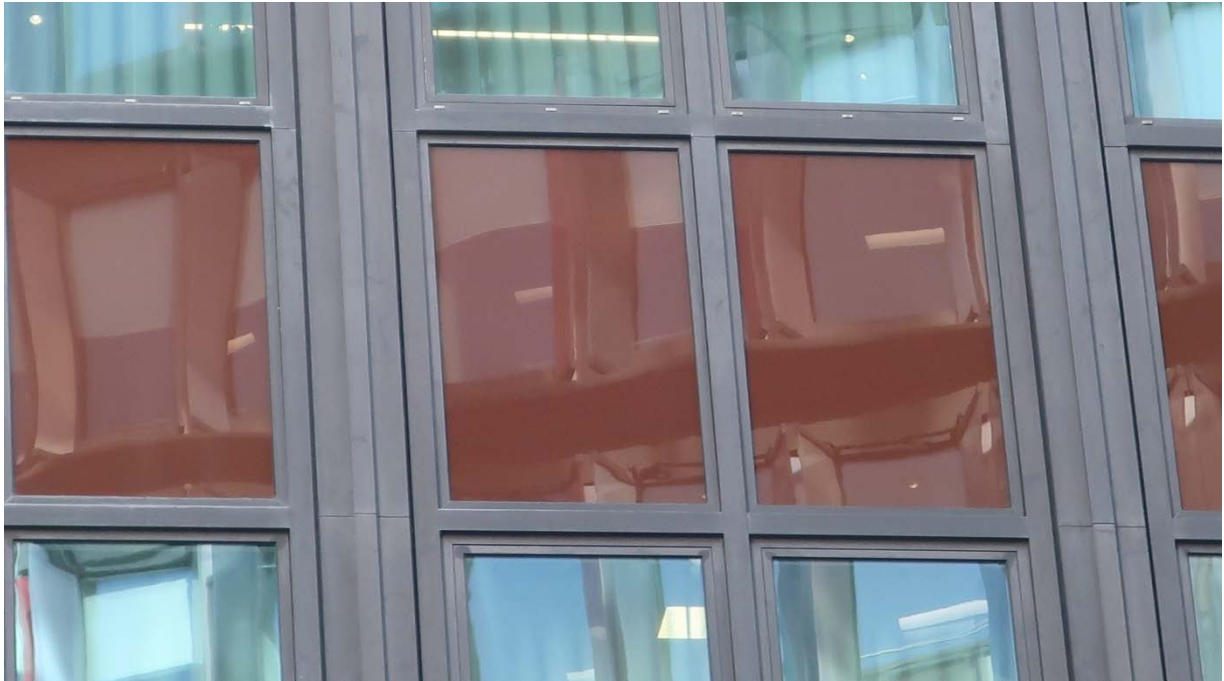
**Photograph 9 – Original curtain walling spandrel panel at floor level.**

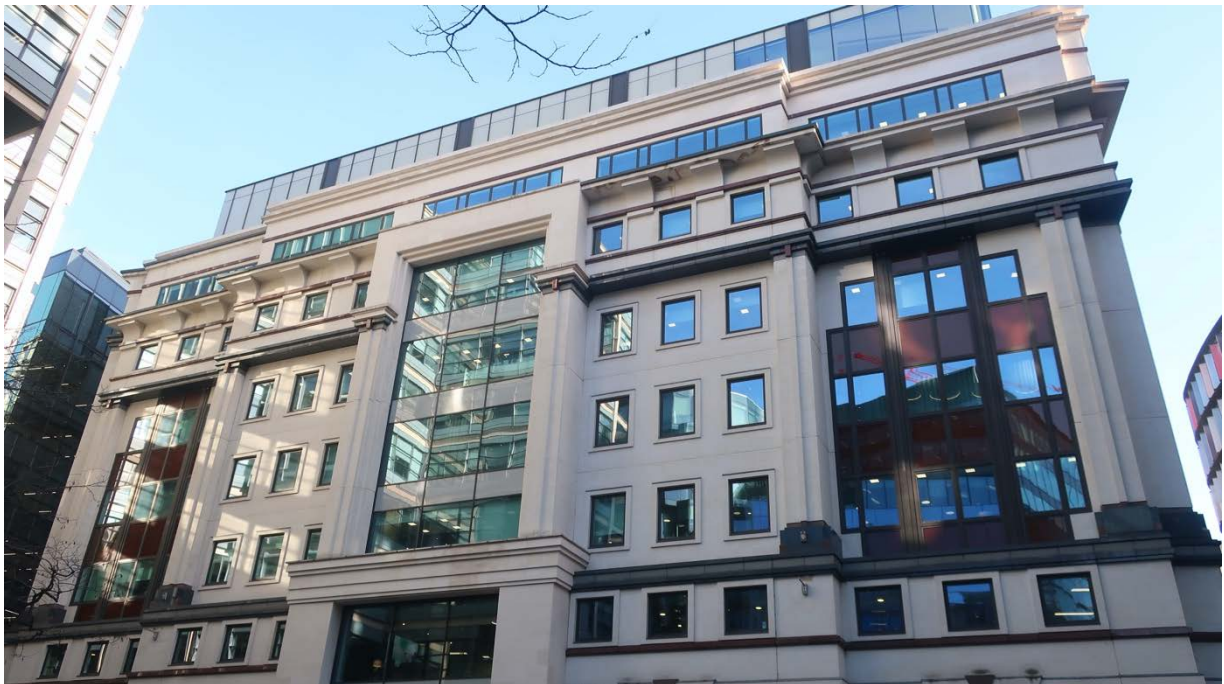
**Photograph 10 – General view of the rear west elevation which is mostly original other than new stonework, windows and curtain walling at high level.**

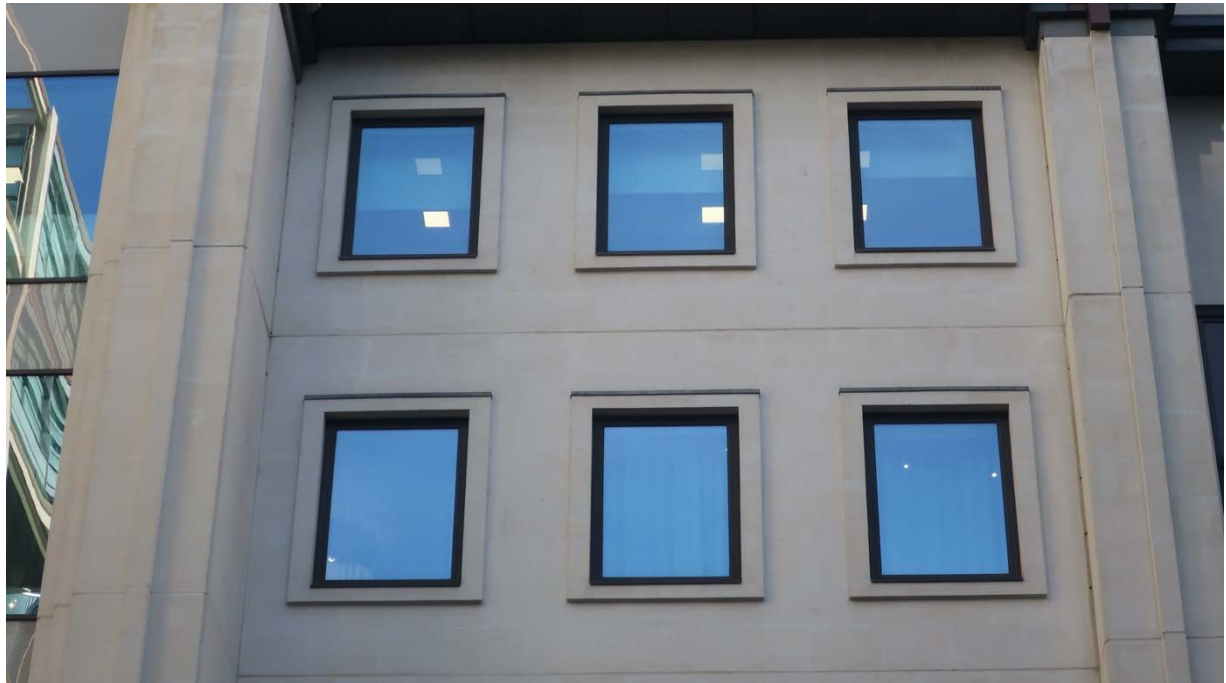
**Photograph 13 – Rear west elevation showing the original stonework and windows.**

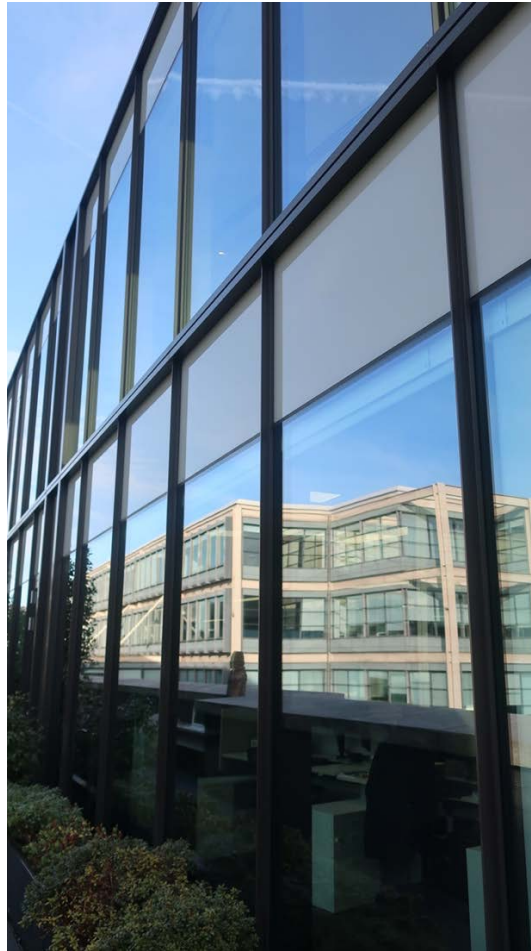
**Photograph 15 – 2017 installed curtain wall at Level 8 & 9.**

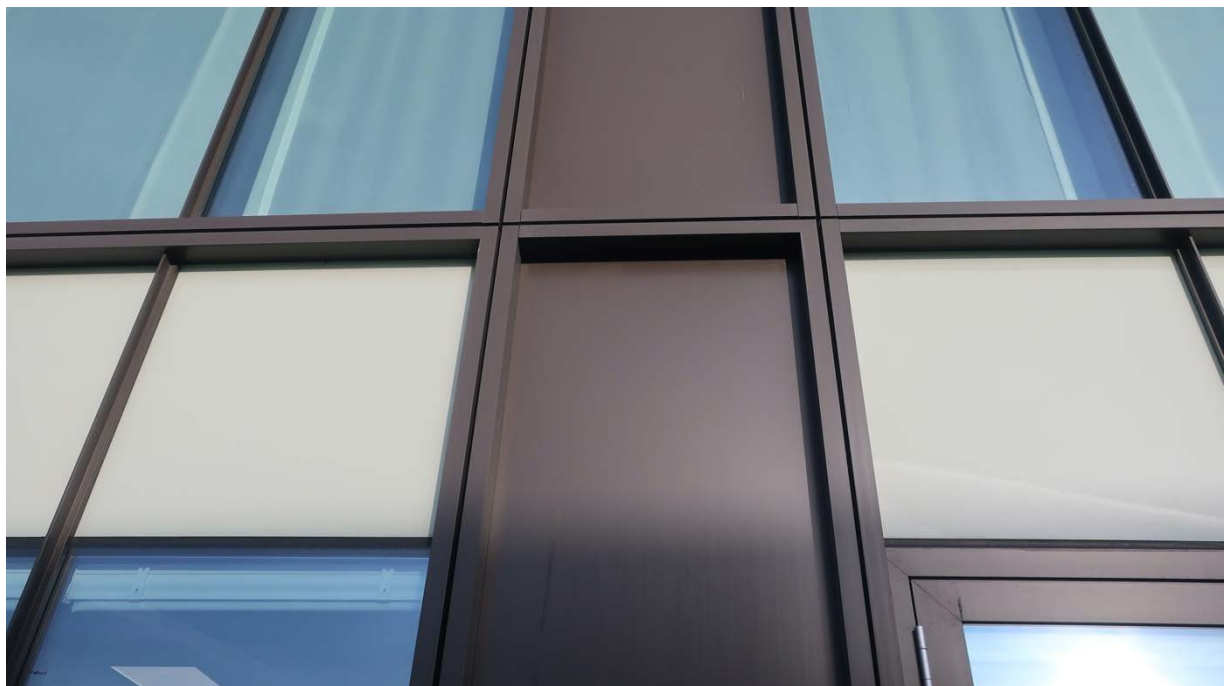
**Photograph 16 – Close view of the 2017 installed curtain wall at Level 8 & 9.**

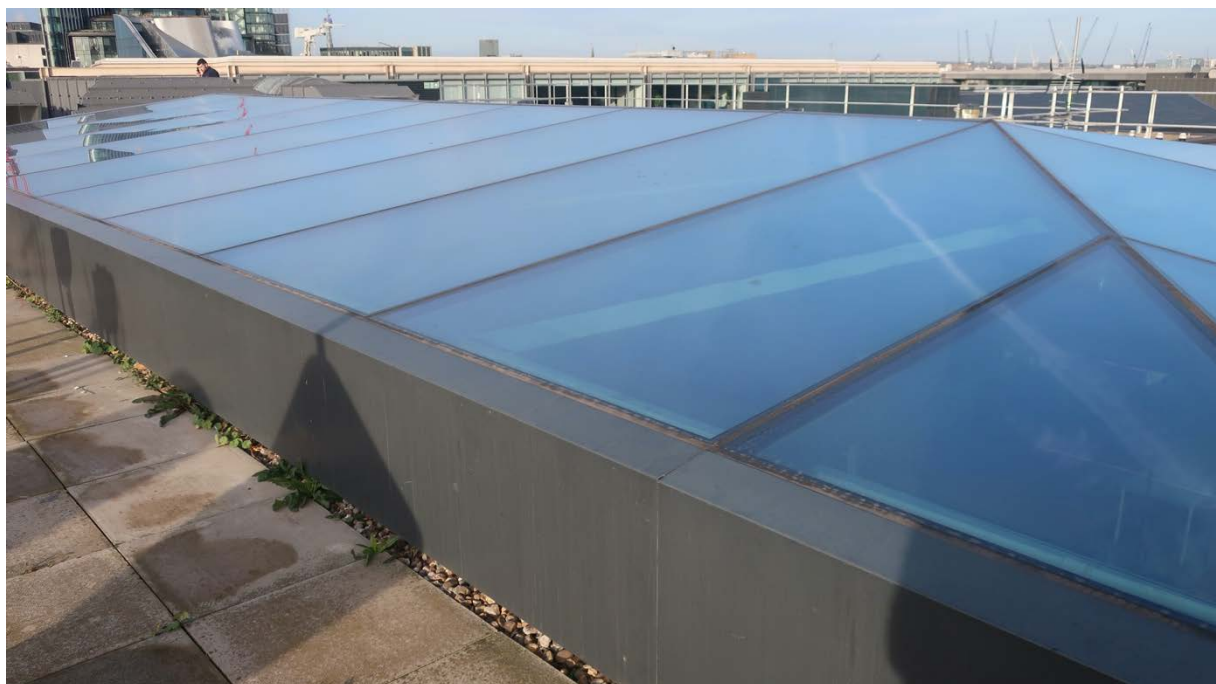
**Photograph 17 – General view of the glazed atrium roof.**

| Item | Description | Impact on investment | Recoverable costs (£) | | | Non-recoverable costs (£) | | |
|---|---|---|---|---|---|---|---|---|
| 3 | Replace broken glazing to atrium as advised by facilities. | Maintenance/programmable repairs. | 27,500.00 | | | | | |
