Vendor's building survey report

## Twenty Old Bailey, London EC4M 7AN

Prepared for: Hines UK Ltd  
Prepared by: Simon Devlin BSc (Hons) MRICS  
Mark Hannan  
Issue date: 14 March 2023  
Report stage: Final  
Reference: 119279-101/SGD

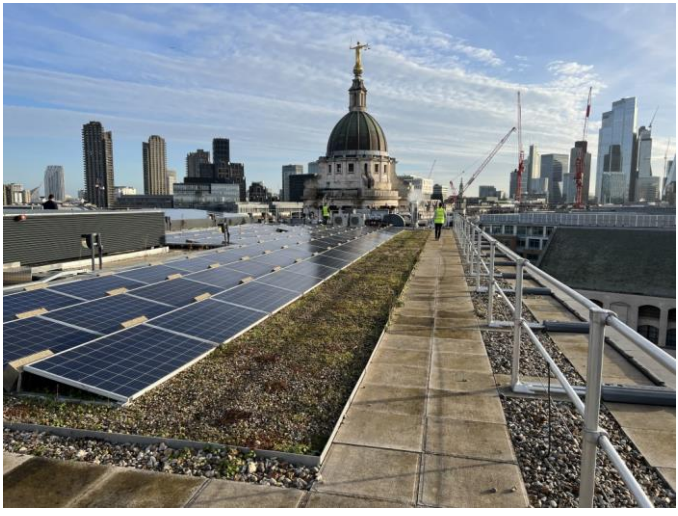
| 1. | Main roof over 9 <sup>th</sup> floor looking east | |

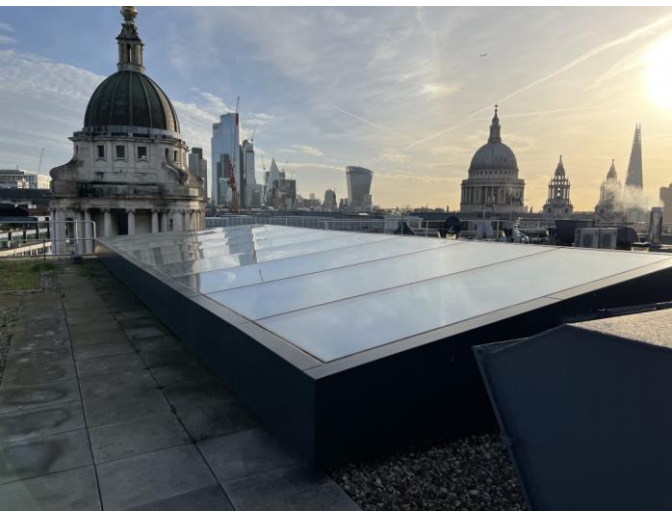
| 5. | Atrium rooflight | |

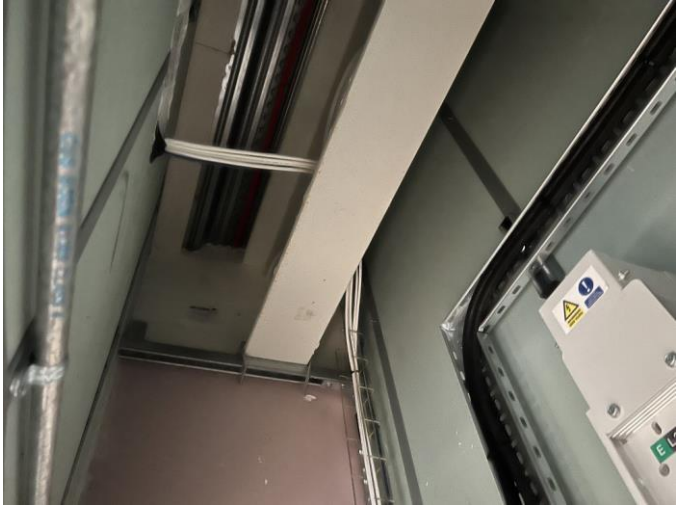
| 9. | Steel with intumescent coating evident within riser | |

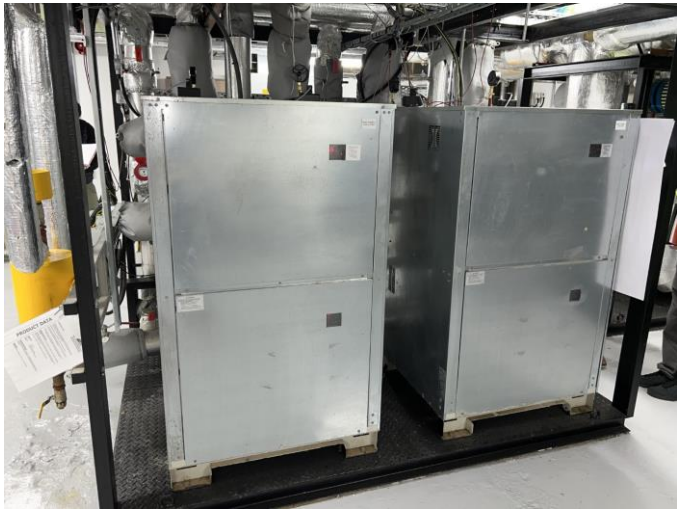
| 1. | Heat pumps. | |

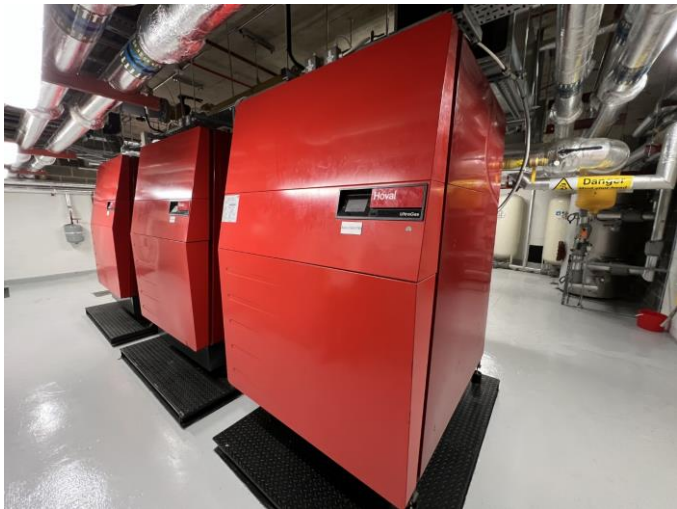
| 2. | Gas fired boilers. | |

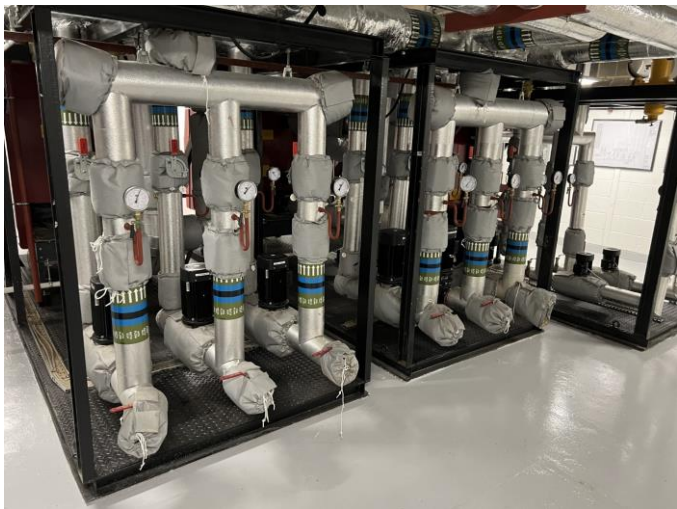
| 3. | LTHW pumps. | |

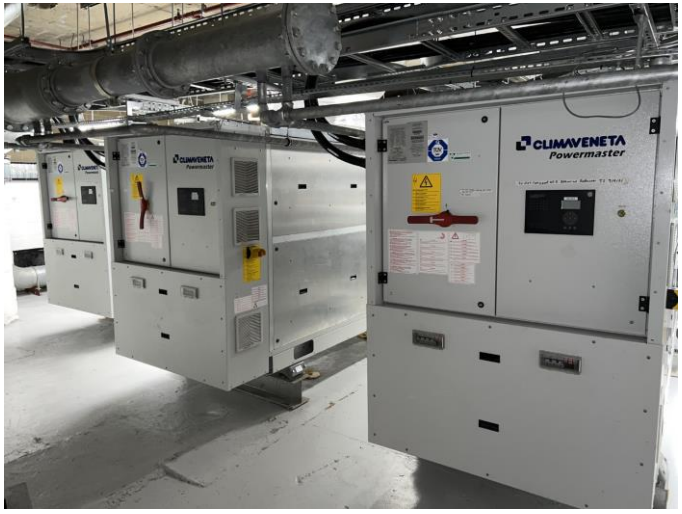
| 4. | Water cooled chillers. | |

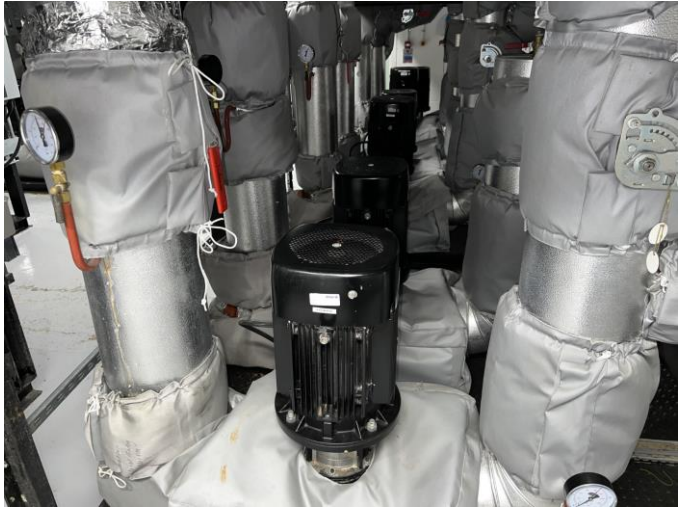
| 5. | CHW pumps. | |

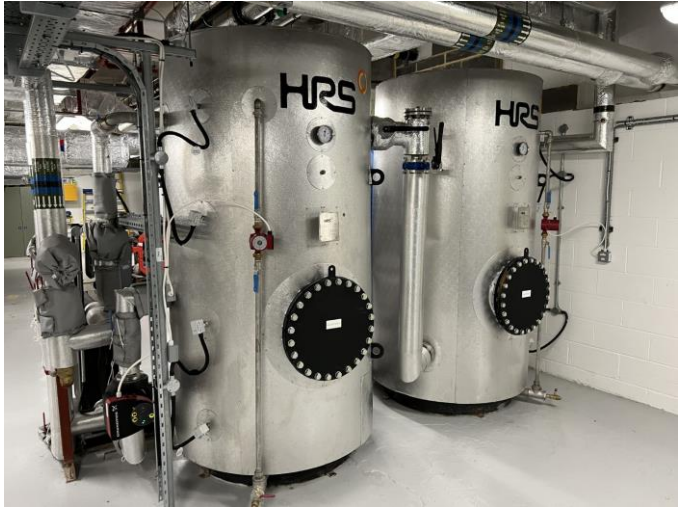
| 6. | DHW calorifiers. | |

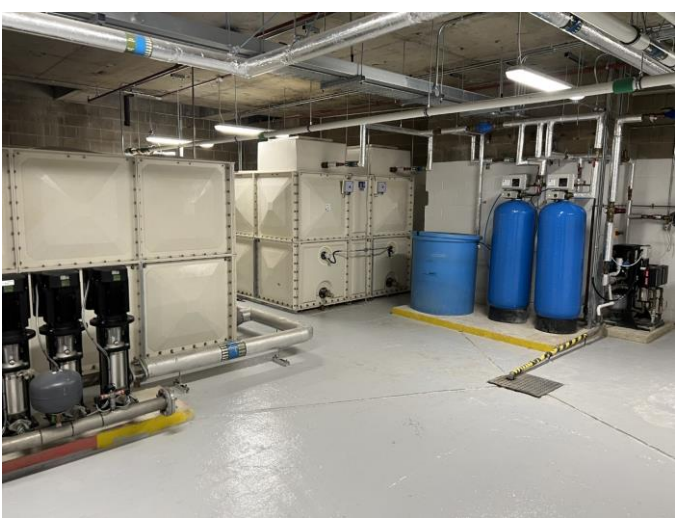
| 7. | CWS tank and cooling tower break tank. | |

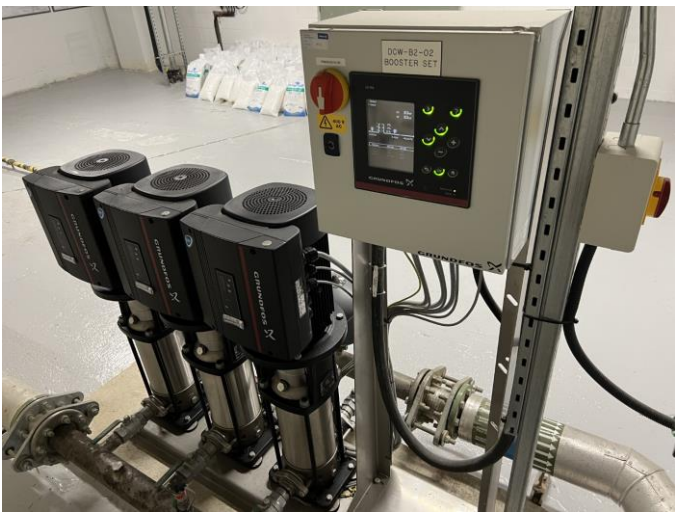
| 8. | CW booster set. | |

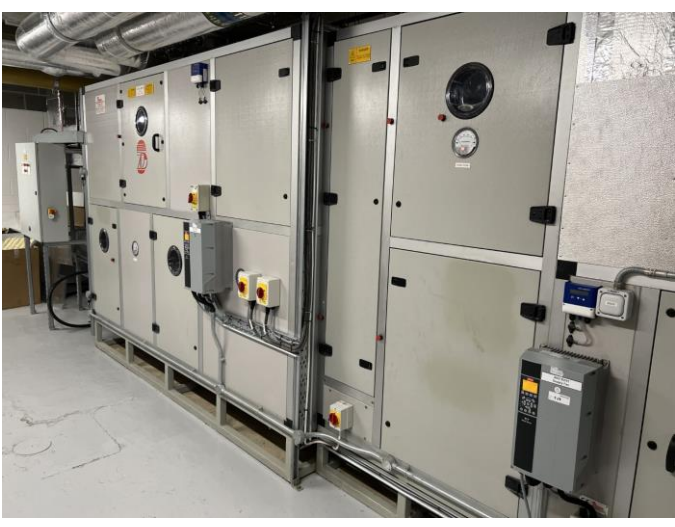
| 9. | Example of AHU. | |

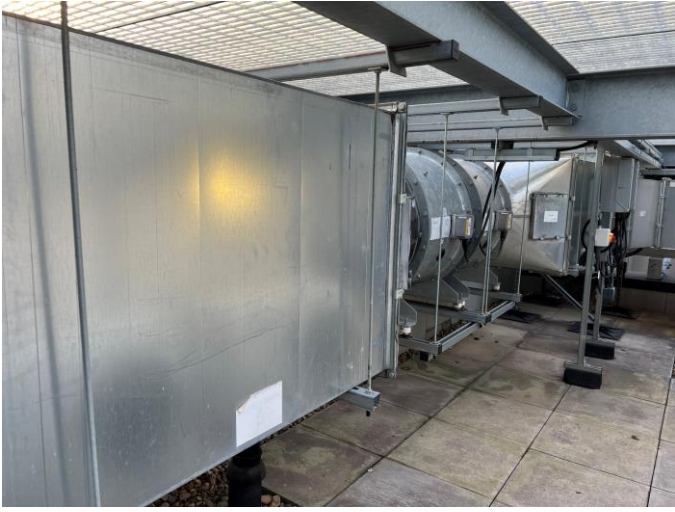
| 10. | Toilet extract fans. | |

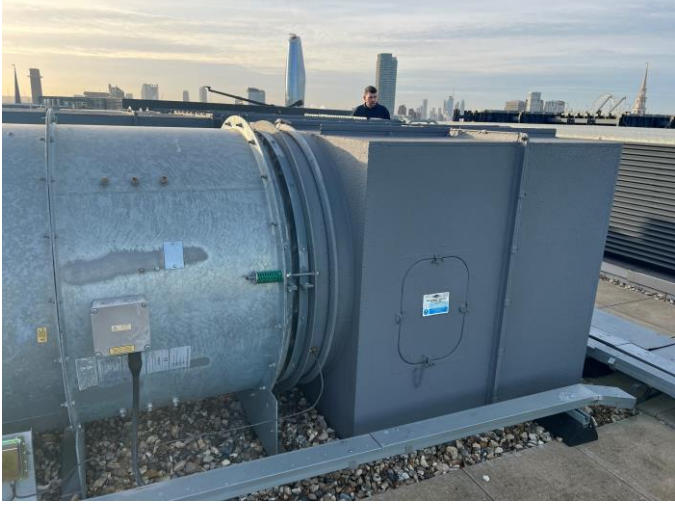
| 11. | Atrium extract fans. | |

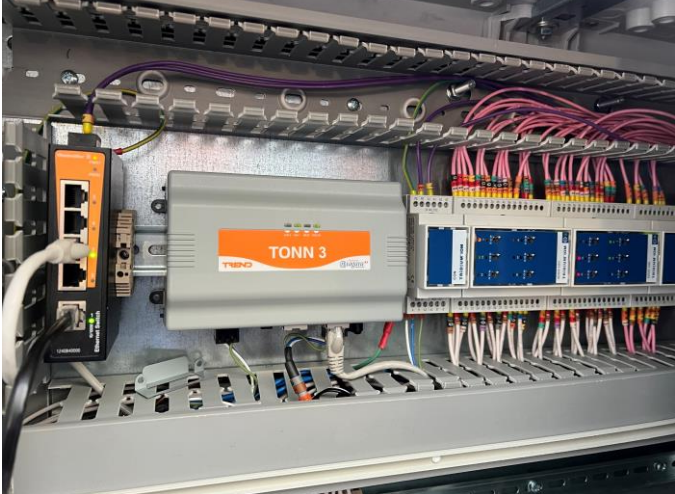
| 12. | BMS controllers (roof MCP). | |

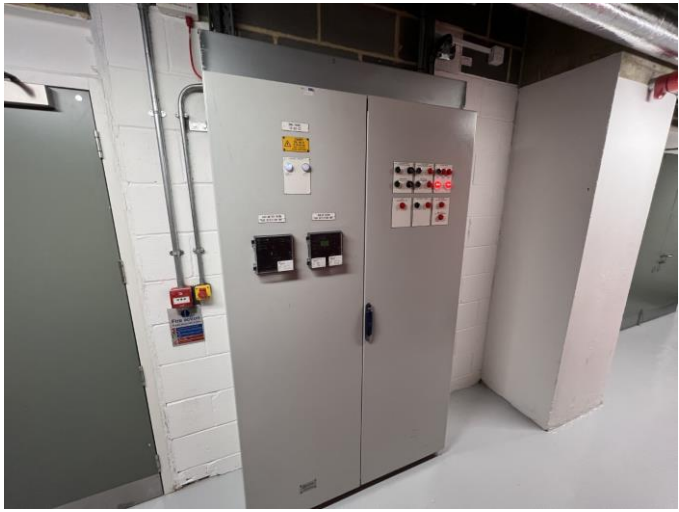
| 13. | MCP (basement). | |

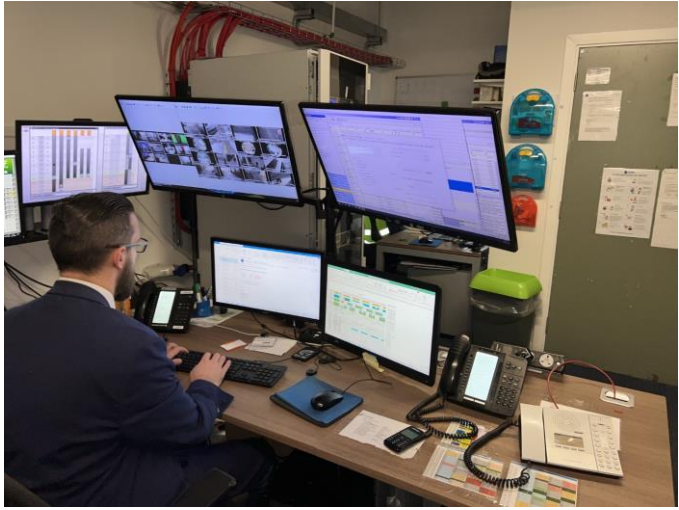
| 14. | BMS head end and CCTV monitors. | |

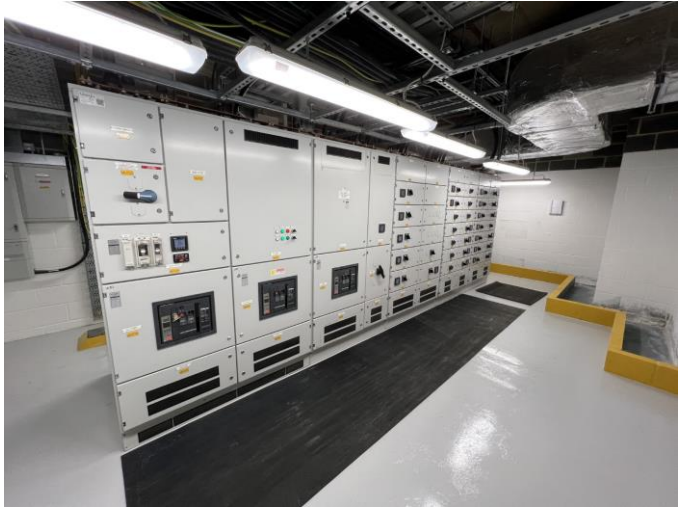
| 15. | Example of main switchboard. | |

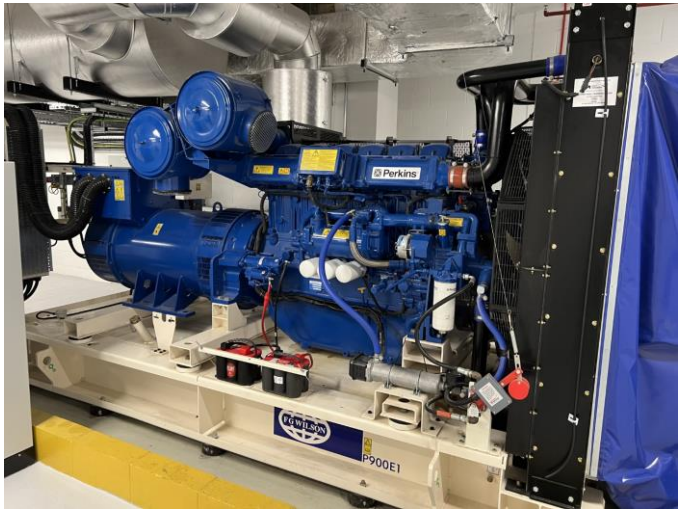
| 16. | Diesel generator. | |

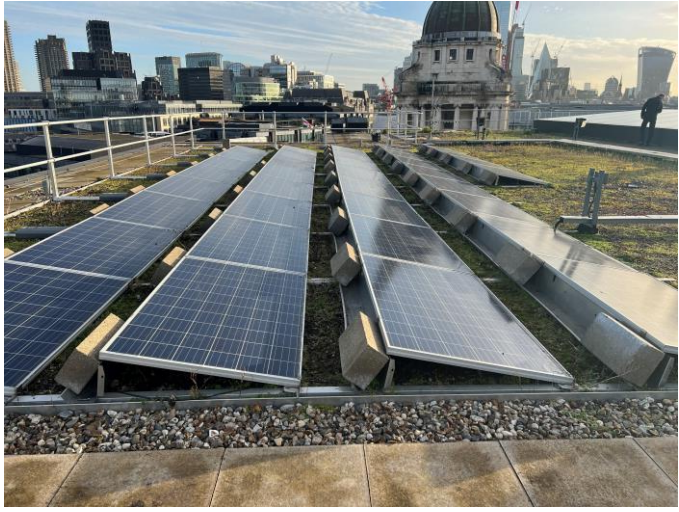
| 17. | PV panels. | |

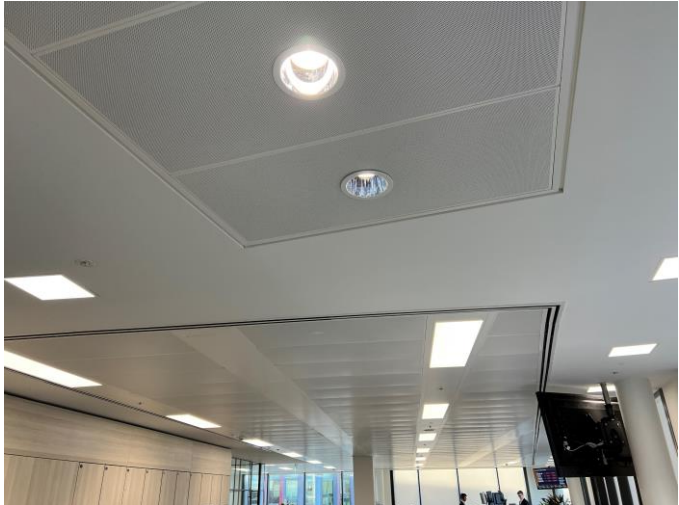
| 18. | Example of office floor lighting. | |

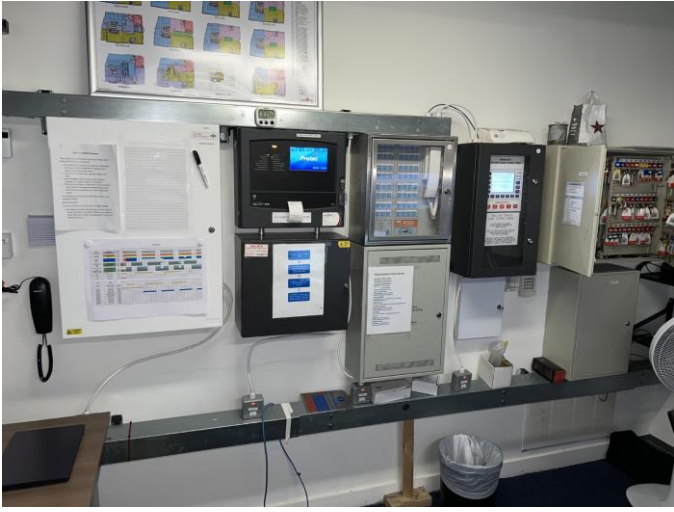
| 19. | Main fire panel and refuge communication panel. | <p>A photograph showing a control room with multiple fire alarm panels and communication equipment mounted on a wall. There are several screens, buttons, and a telephone. A small table in front of the panels holds some papers and a pen.</p> |

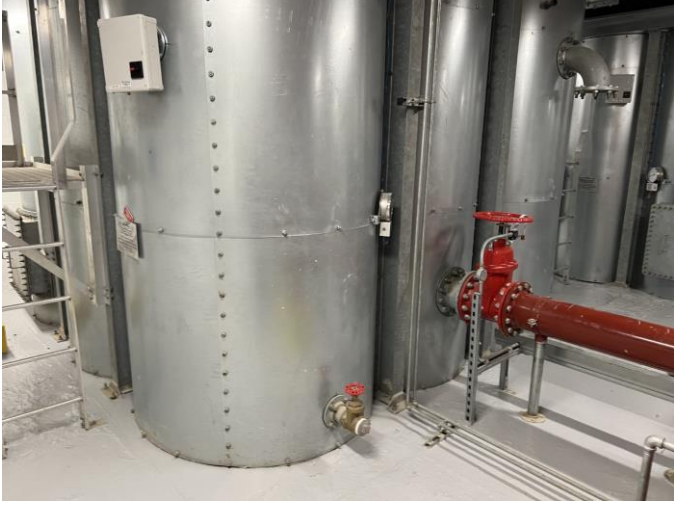
| 20. | Sprinkler tank. | <p>A photograph of a large, cylindrical, stainless steel sprinkler tank. The tank is situated in a room with other industrial equipment. A red fire hose is connected to the tank's side.</p> |

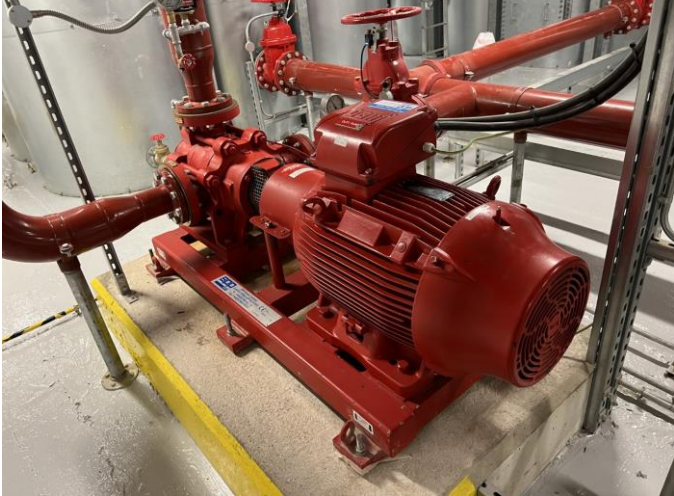
| 21. | Example of sprinkler pump. | <p>A photograph of a red fire pump unit. The pump is mounted on a metal frame and has a large red motor. It is connected to a network of red pipes and valves.</p> |

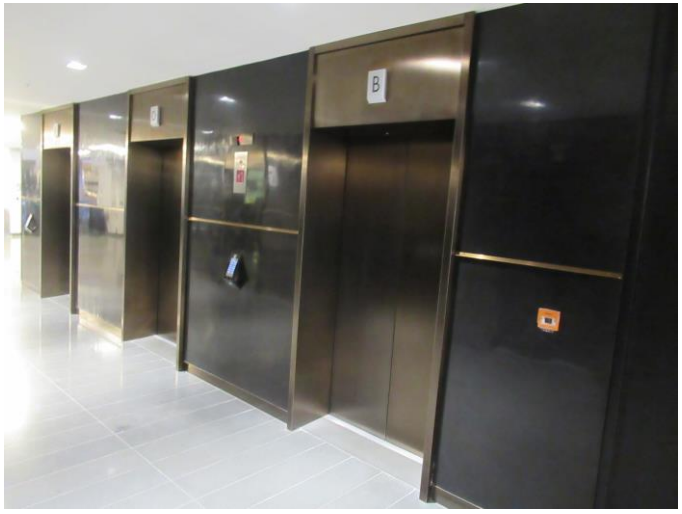
| 22. | Six car group of passenger / goods lifts ground floor landing lobby. | |

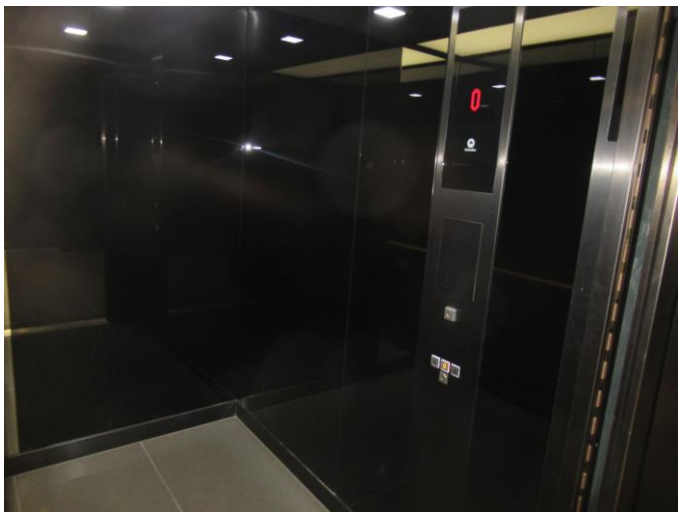
| 1. | Six car group of passenger / goods lifts typical car interior. | |

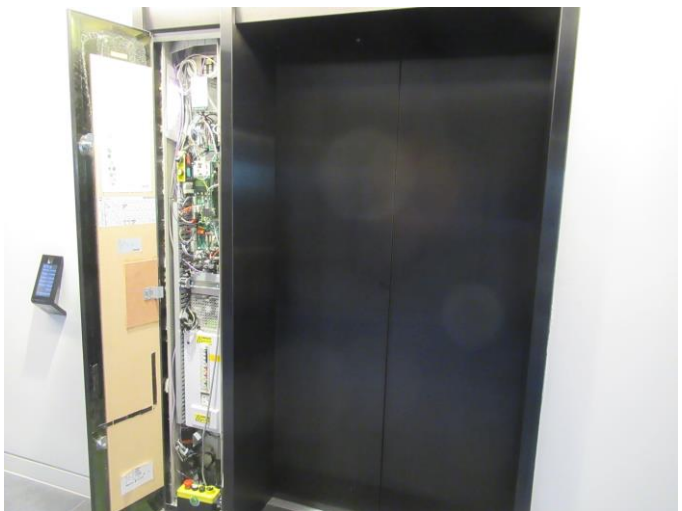
| 2. | Six car group of passenger / goods lifts typical intervention panel adjacent to the top floor entrance. | |

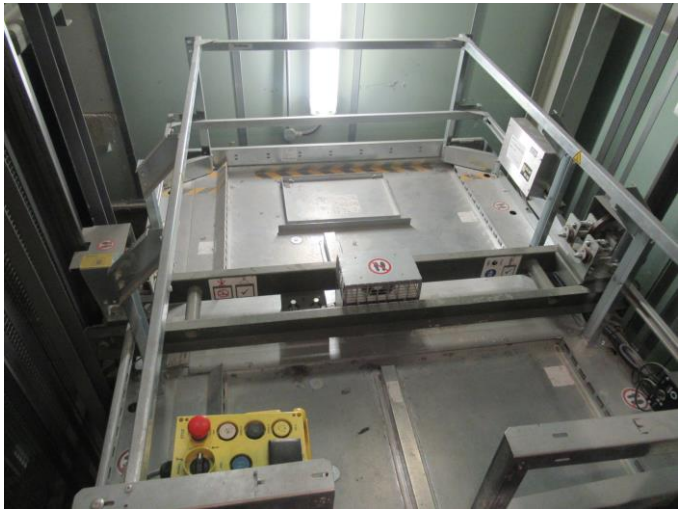
| 3. | Six car group of passenger / goods lifts typical car top view. | A photograph showing the top of a lift platform. The platform is a large, flat, rectangular metal surface with a yellow control panel on the left side. It is surrounded by a metal frame and safety railings. The background shows the interior of a building with concrete walls and a ceiling. |

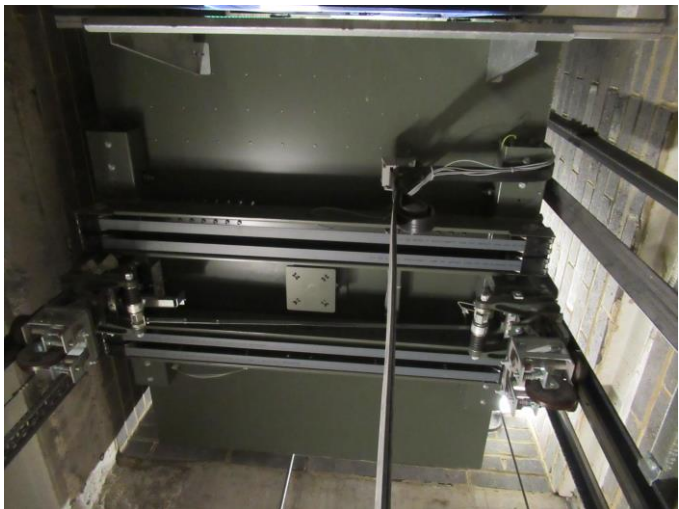
| 5. | Six car group of passenger / goods lifts typical under car view. | A photograph showing the underside of a lift platform. The view is looking up at the platform, which is supported by a complex metal structure. The platform is a large, flat, rectangular metal surface. The background shows the interior of a building with concrete walls and a ceiling. |

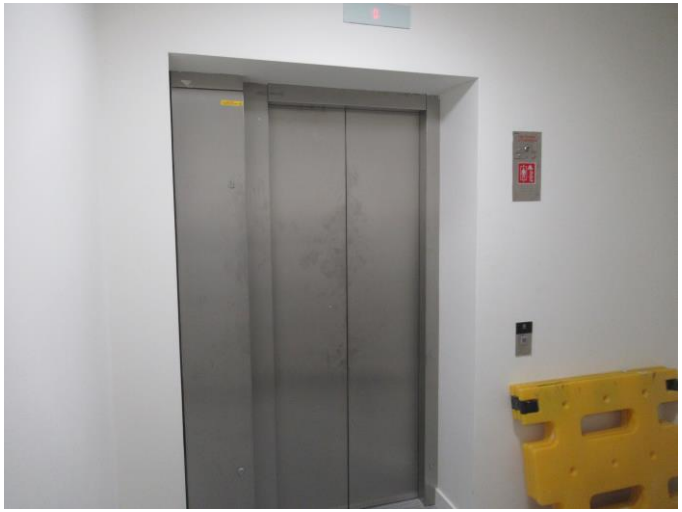
| 6. | Core 3 firefighters lift ground floor entrance with the firefighters switch to the right-hand side. | |

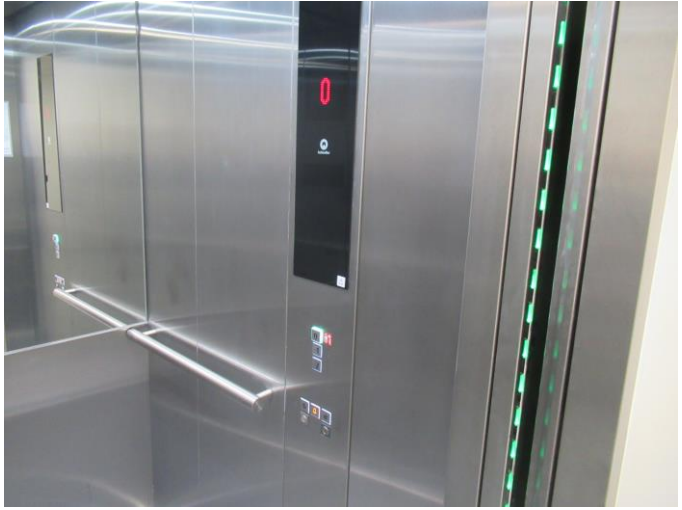
| 7. | Core 3 firefighters lift car interior. | |

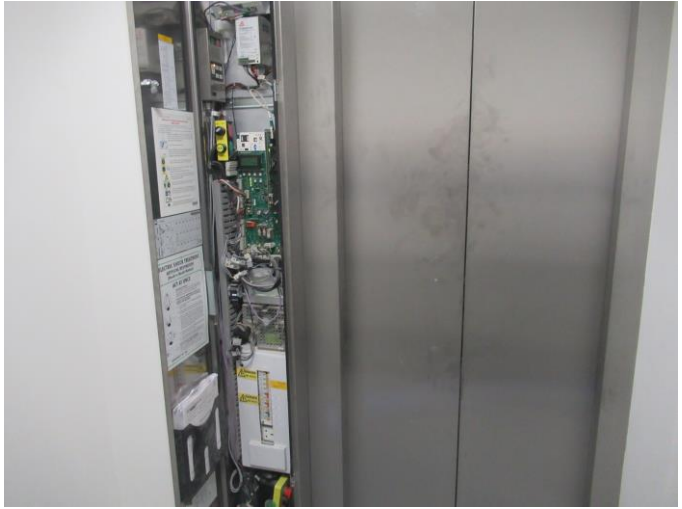
| 8. | Core 3 firefighters lift intervention panel. | |

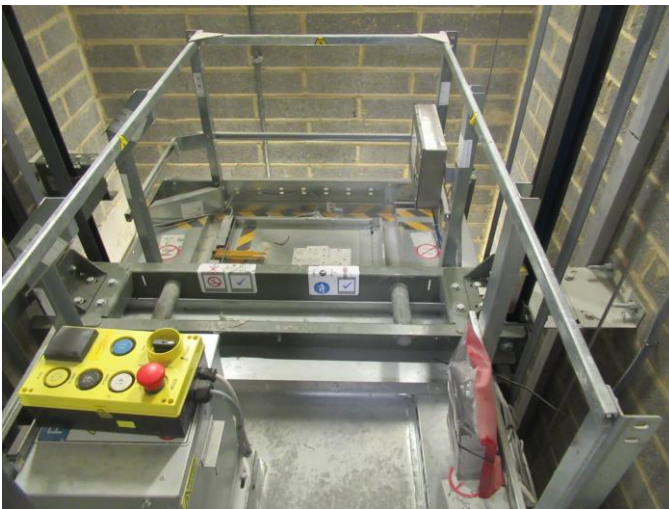
| 9. | Core 3 firefighters lift car top view. | |

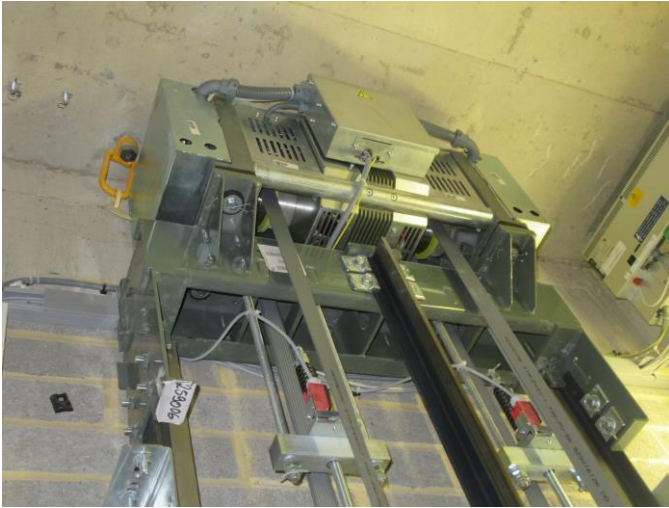
| 10. | Core 3 firefighters lift gearless hoisting machine. | |

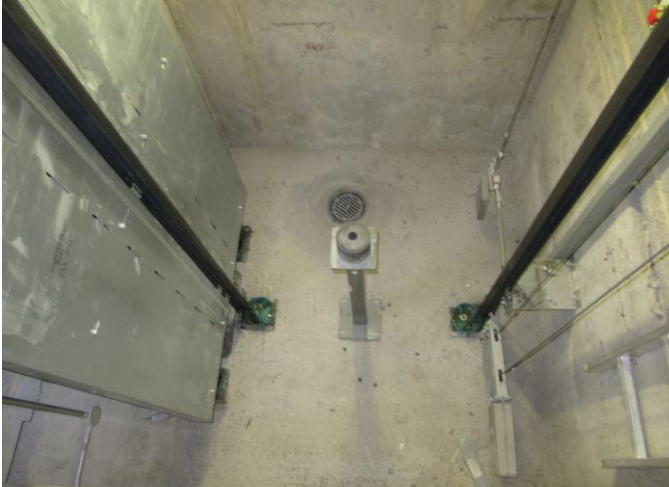
| 11. | Core 3 firefighters lift pit view. | |

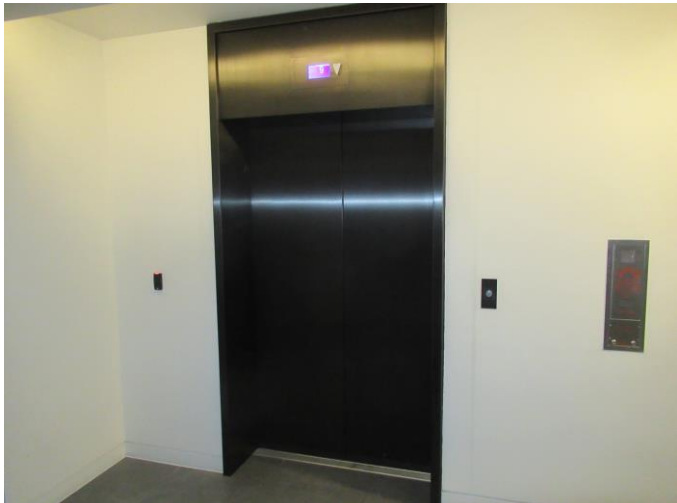
| 12. | Passenger / goods (goods) lift typical landing entrance. | |

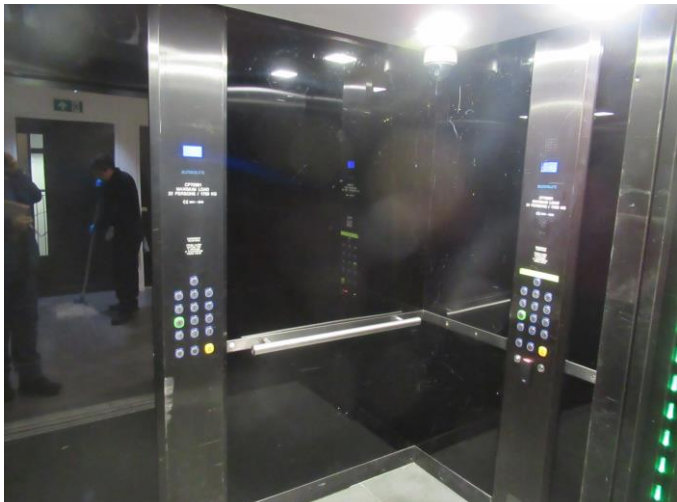
| 13. | Passenger / goods (goods) lift car interior. | |

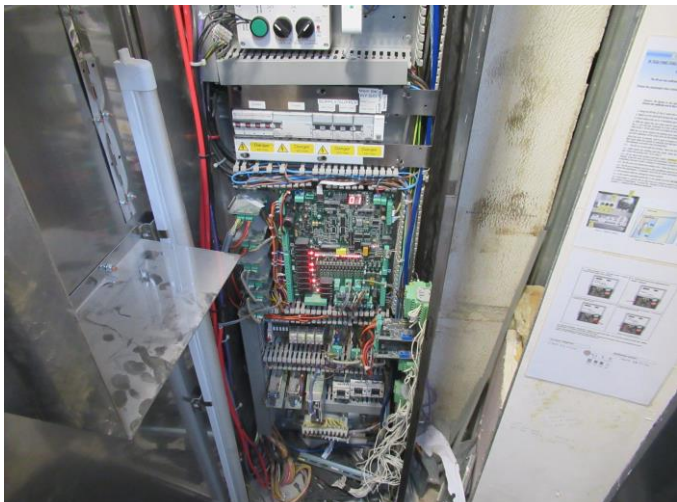
| 14. | Passenger / goods (goods) lift controller. | |

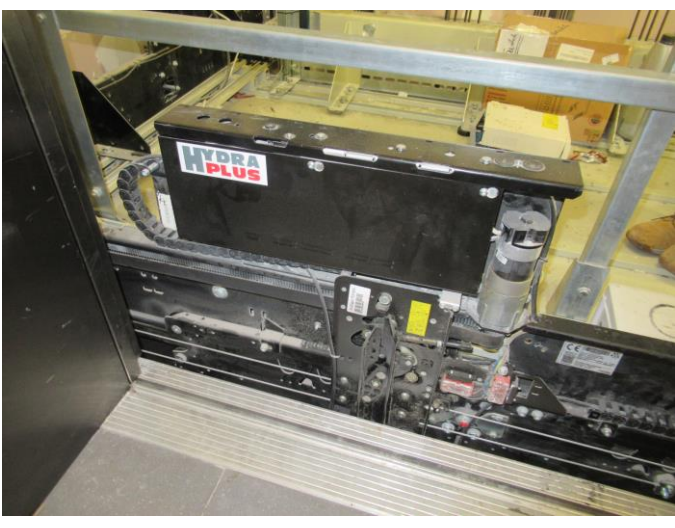
| 16. | Passenger / goods (goods) lift typical car door operator. | |

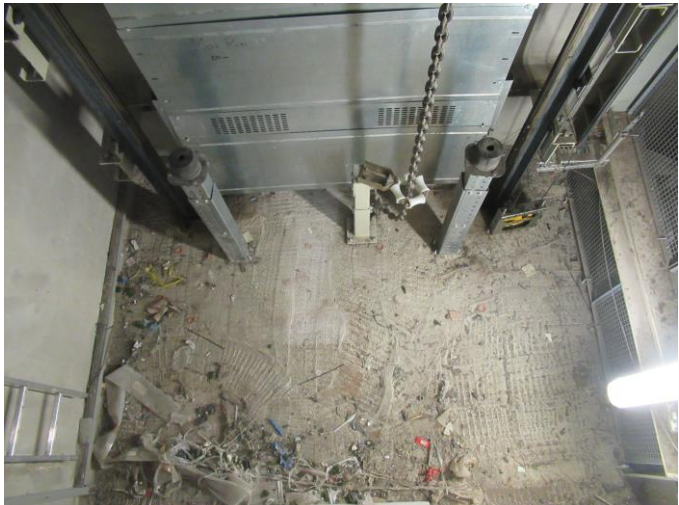
| 18. | Passenger / goods (goods) lift pit view. | |

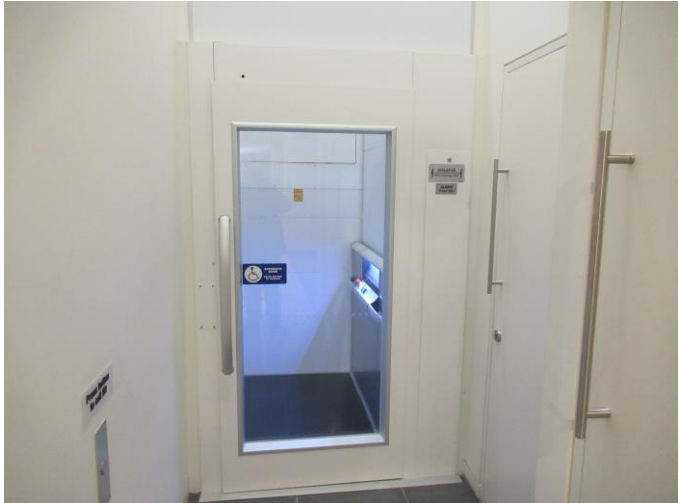
| 19. | Accessibility platform hoist reception level landing entrance. | |

| Item | Description | Impact on investment | Recoverable costs (£) | | | Non-recoverable costs (£) | | |
|---|---|---|---|---|---|---|---|---|
| 12 | The accessible platform hoist will require to be refurbished at the end of its economic serviceable life. | M&E lifecycle replacement. | | | 41,800.00 | | | |

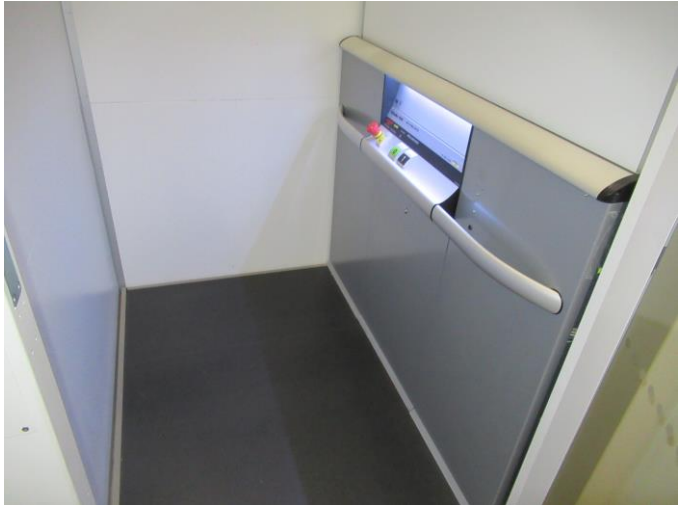
| 20. | Accessibility platform. | |

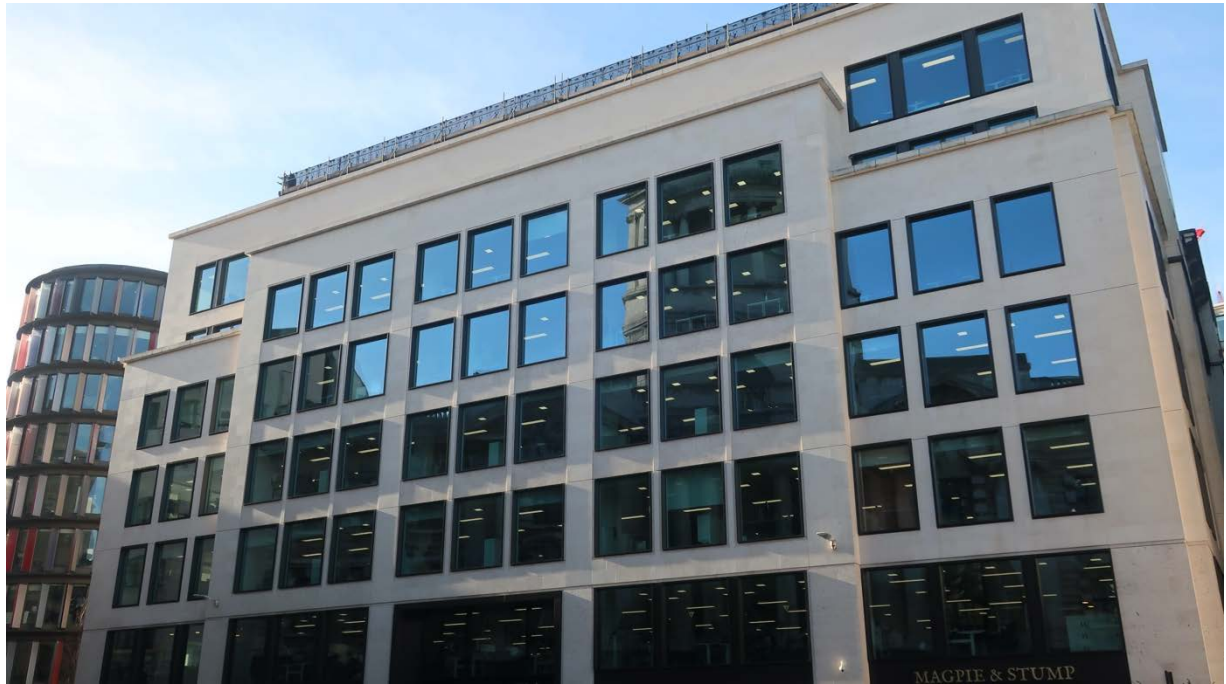
**Photograph 1 – General view of the front east elevation constructed in 2017.**

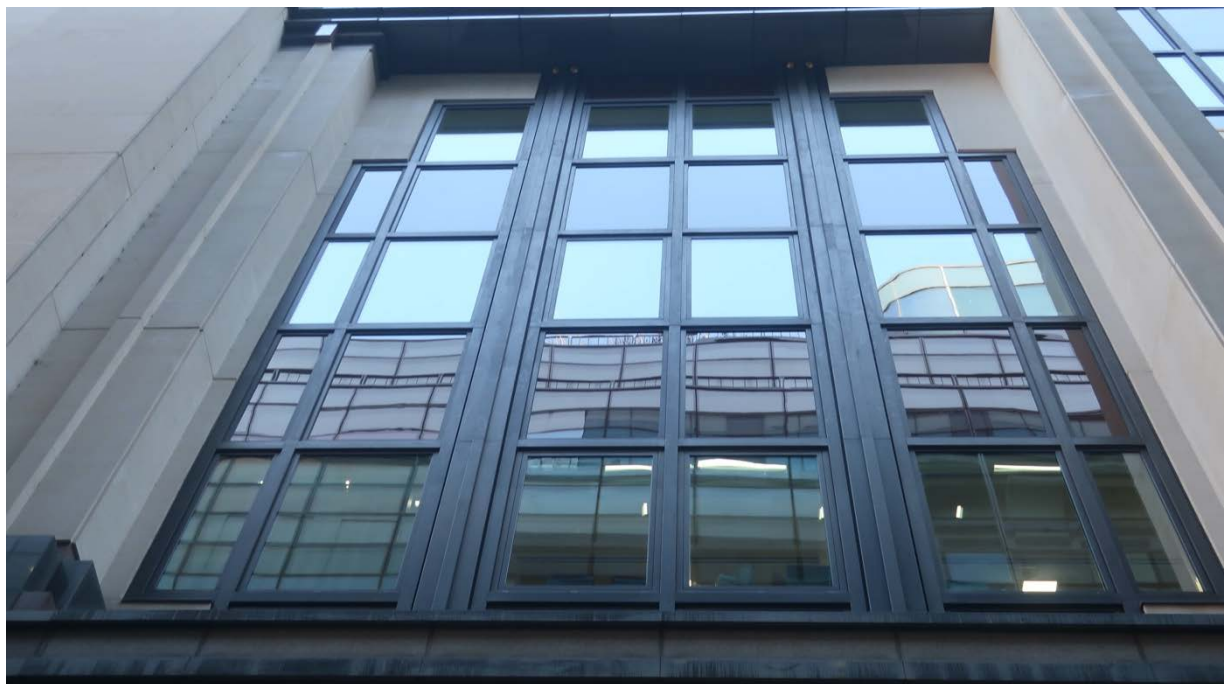
**Photograph 6 – North elevation showing original infill area of curtain walling.**

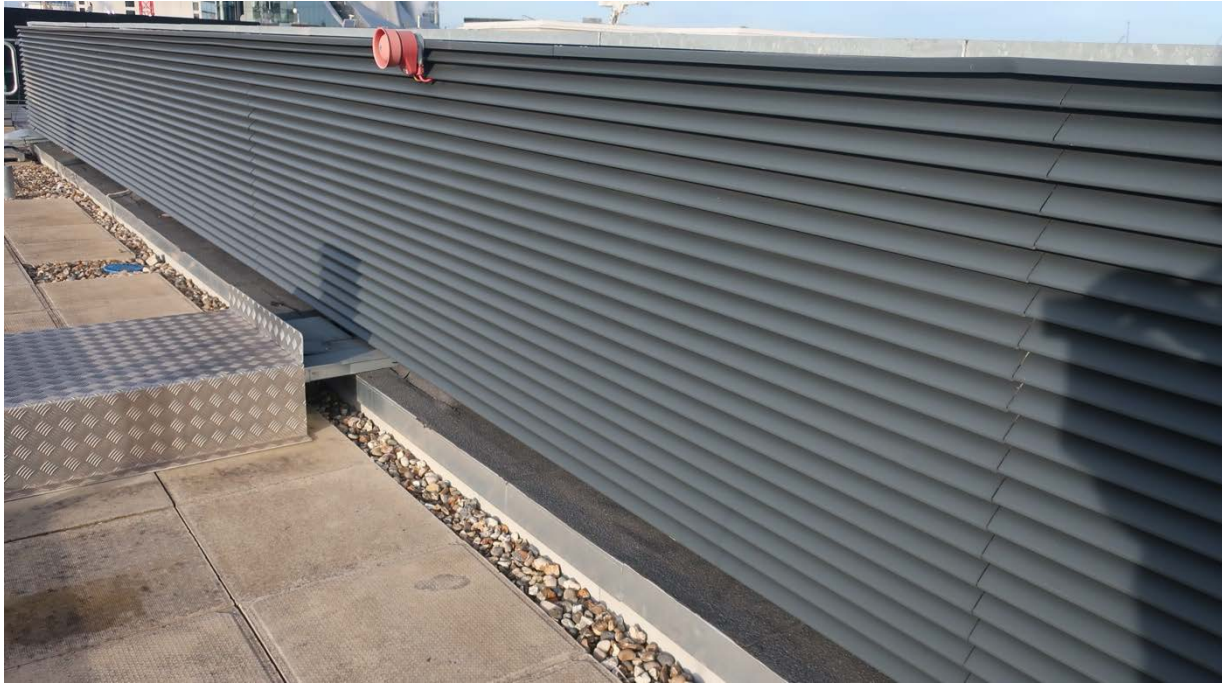
**Photograph 19 - General view of the louvre blade open plant enclosure at roof level.**
